API-653 Inspection Report
Modified for Out-of-Service Inspection of Fertilizer Tanks

Nutrien Ag Solutions - Five Points
Mount Sterling, Ohio

October 6, 2020

Tank # 1
51' Diameter x 32' High Tank
Carbon Steel Construction
28% Nitrogen Solution

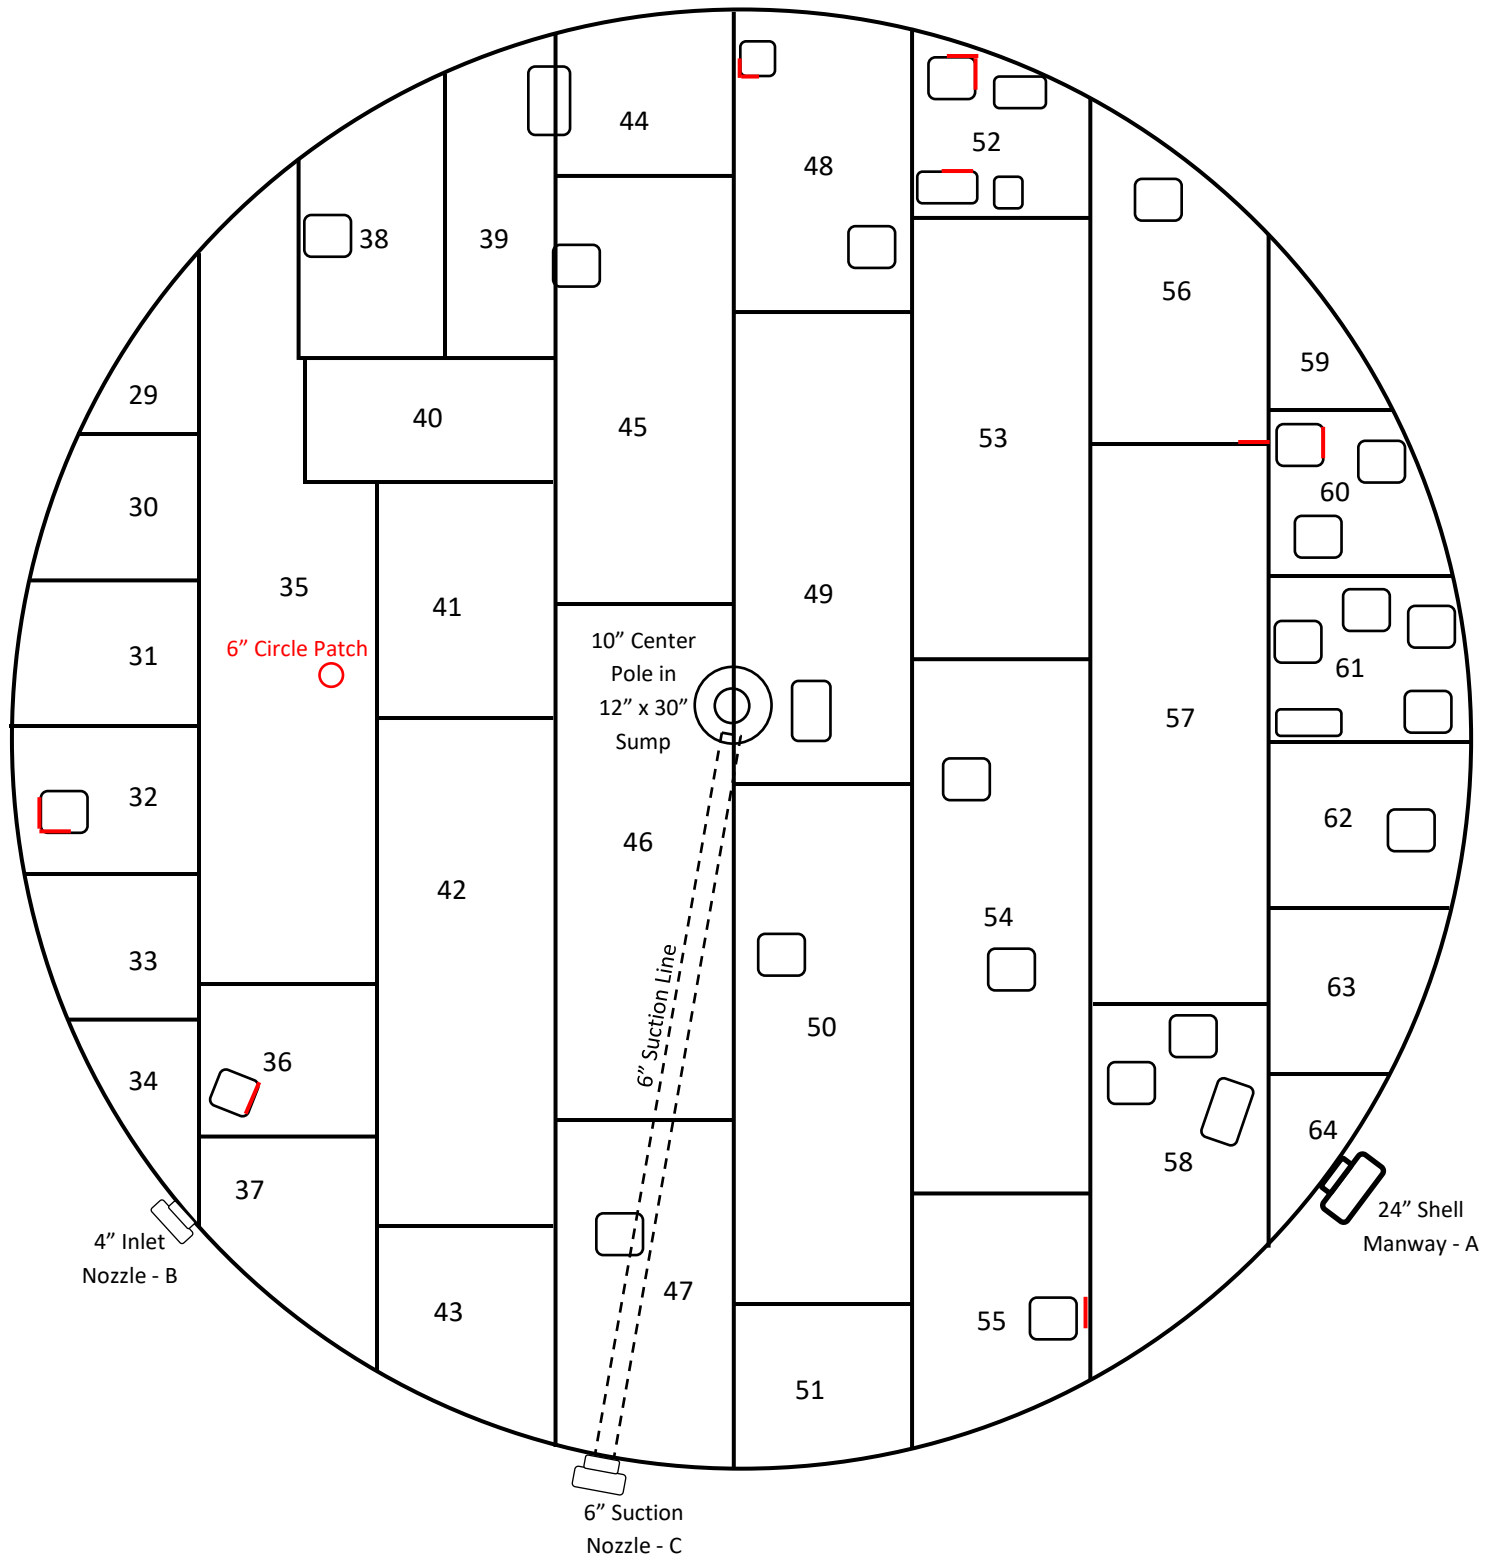
FLOOR CML LOCATIONS

- 3.5.2 Floor plates were visually examined and found to be in fair condition with corrosion present where the internal coating has failed.
- 3.5.3 *Floor weld joints were visually examined and found to have severe corrosion damage in areas where internal coating has failed. Although the vacuum test completed in these areas did not reveal leaks, the weld joints have been marked with orange spray paint for immediate repair.*

- 3.5.3.1 There are seven patch plates that have corrosion damage on the weld joints in need of repair. There is approximately one-foot (1') of floor weld joint repair needed as well.*

- 3.5.3.2 There are existing floor patch plates installed that do not meet API requirements.*
 - 3.5.3.1.1 During inspection, no leaks or issues were found in these areas. The tank has been in service with the code violations at Owner's knowledge. Continued use after repairs is at Owner's Risk.*

- Weld joints needing repair
- Lap patch plate needed for repair

- 4.5.1 Owner should repair, to API Specifications, the marked damaged floor weld joints and patch plate weld joints with low hydrogen welding rods prior to returning tank into service. Refer to section 5.0 – Floor CML locations for areas needing repair.
- 4.5.2 Owner should reapply internal coating on the repairs and other areas of the floor missing internal coating after weld joint repairs are complete to prevent future corrosion damage.

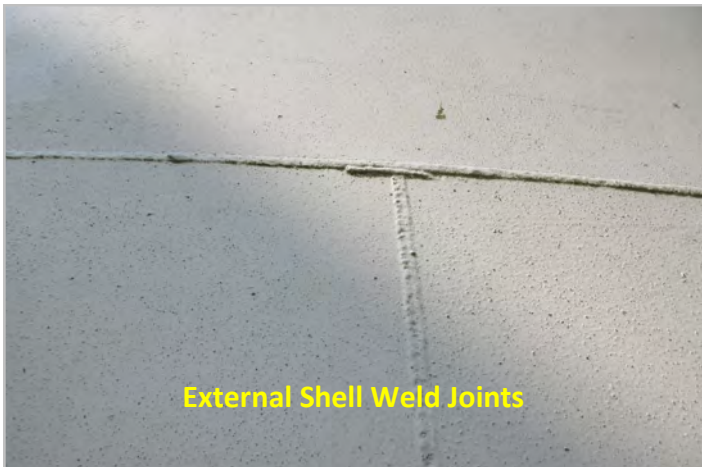
- 3.2.3 A visual examination revealed the external shell plates and weld joints to be in good condition with minor corrosion damage present.
- 3.2.4 Visual examination of the internal shell plates and weld joints found the condition to be good with minor corrosion damage present.

External Shell Weld Joints

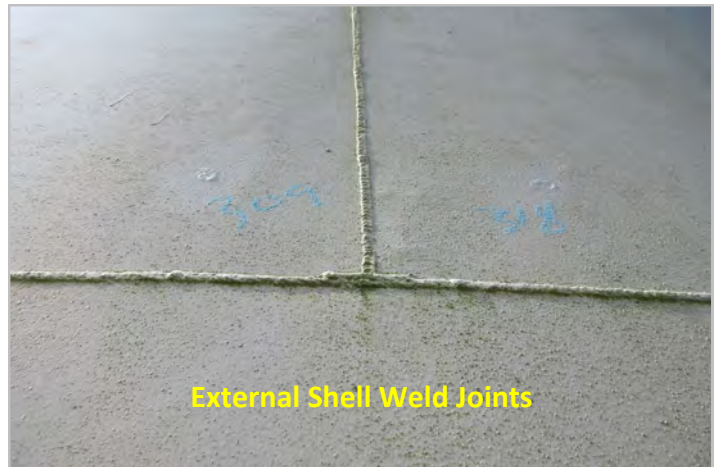
External Shell Weld Joints

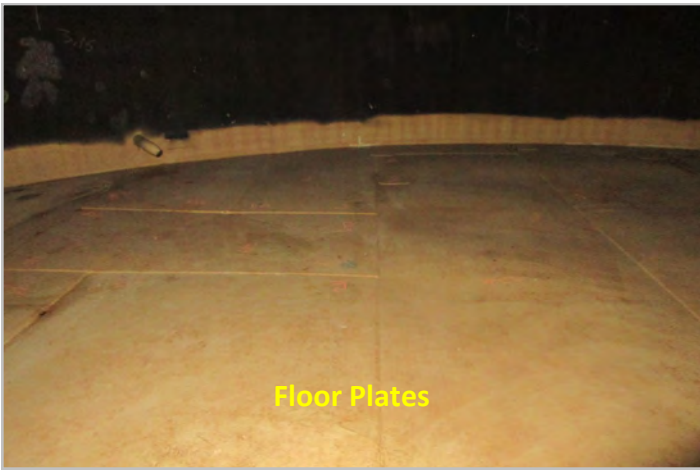
Floor Plates

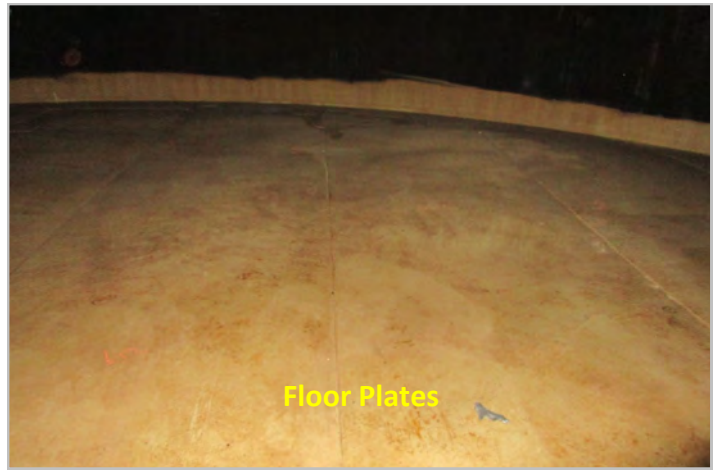
Floor Plates

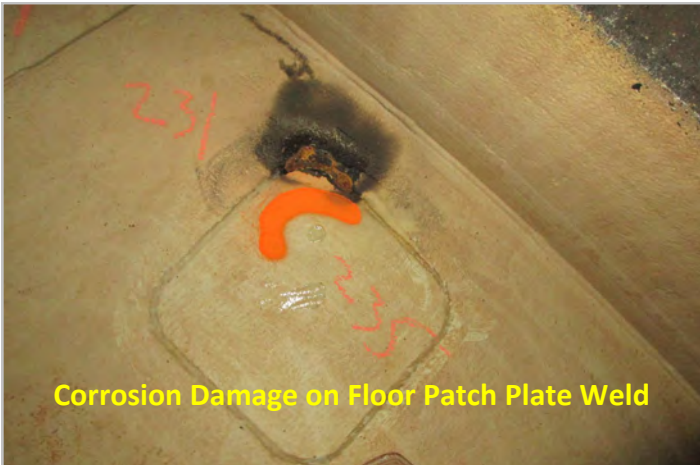
Corrosion Damage on Floor Patch Plate Weld

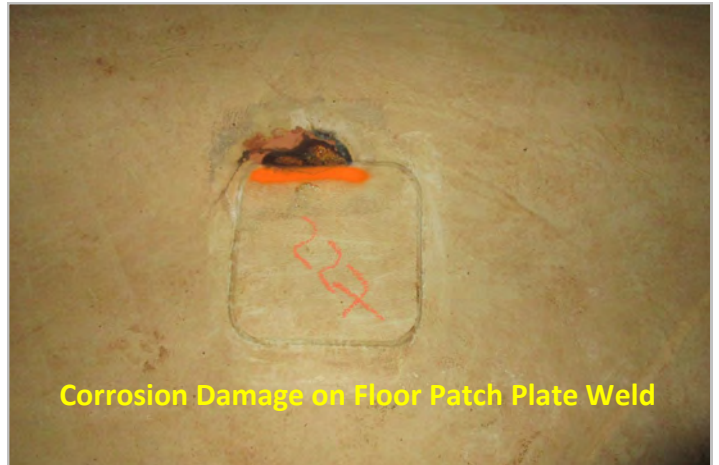
Corrosion Damage on Floor Patch Plate Weld

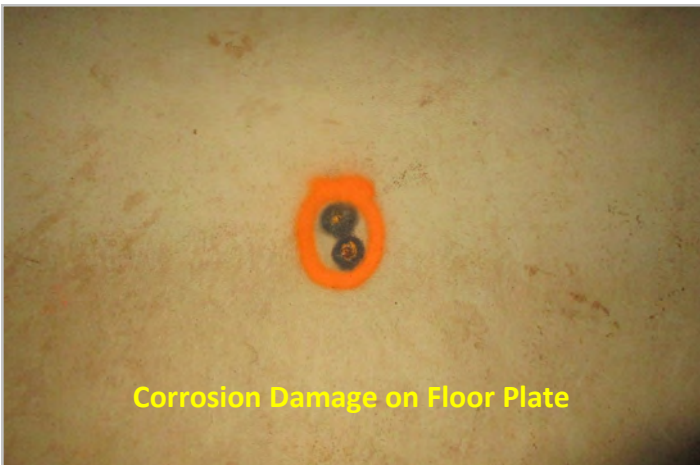
Corrosion Damage on Floor Plate

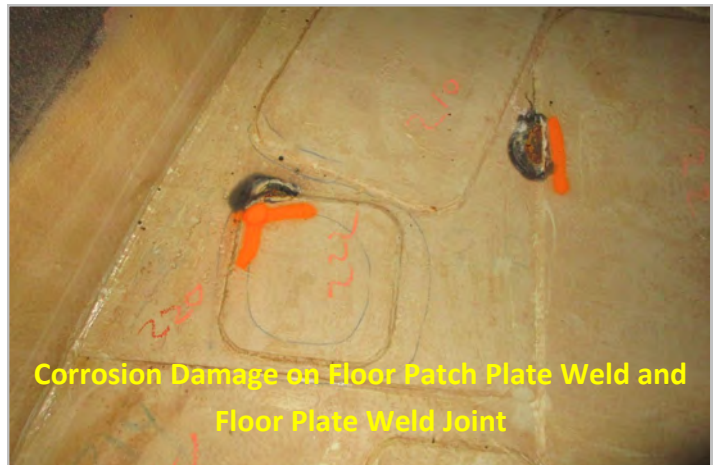
Corrosion Damage on Floor Patch Plate Weld and Floor Plate Weld Joint

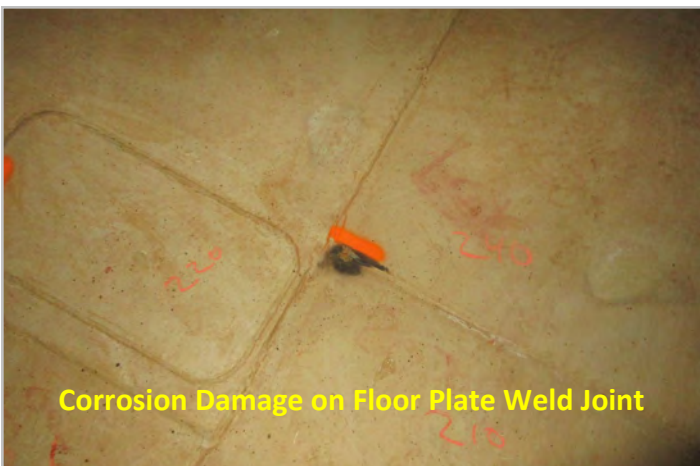
Corrosion Damage on Floor Plate Weld Joint
